Inspection

PASS pole testing

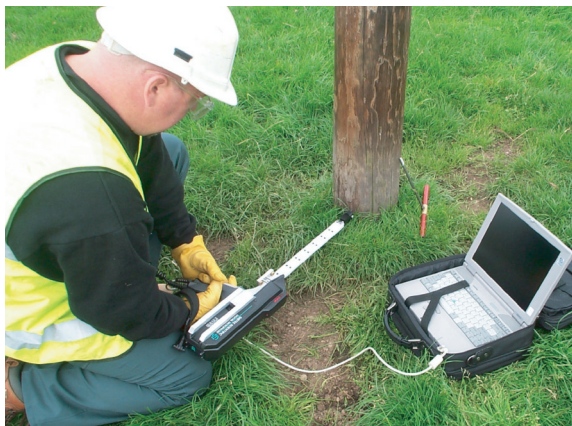
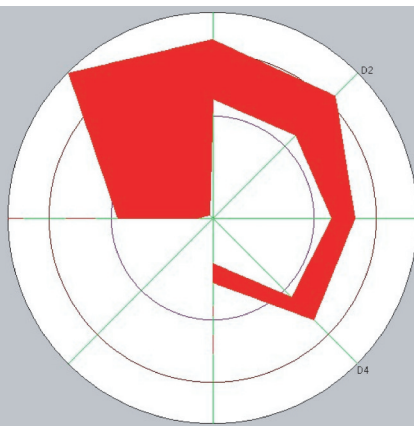
Rot Determination

The decay information can be entered via a microprobe drill, the results of which are converted into a display. The decay information can also be identified visually or by Mattson bore techniques and entered manually by the operator drawing the area of rot identified. Representations shown relate to different wood poles inspected.

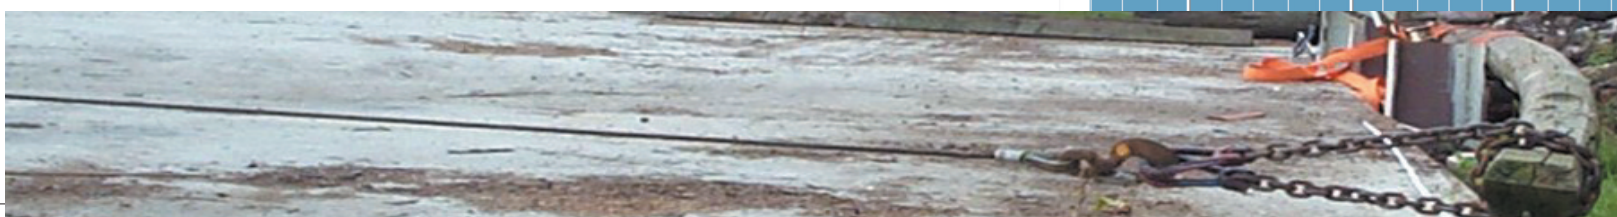
Determination of the wood poles capability to withstand design loads calculated on site relative to:

- Conductor (cable) type
- Conductor number
- Wind span
- Angle of deviation
- Number of stays
- Stay spreads

- Pole grade
- Pole height
- Pole burying depth
- Reduced % RSV

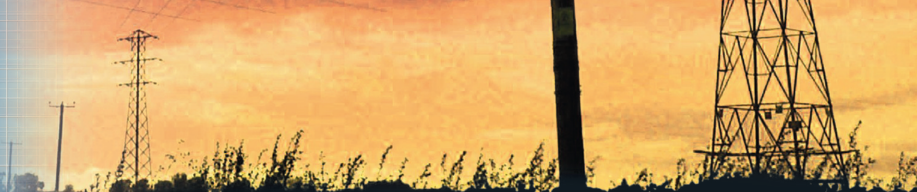
The Pole Foundations pole testing protocol (PASS) is currently approved and recognised by a number of Distribution Network Operators. It is Pole Foundations aim to be recognised as the preferred wood pole testing and evaluation service provider in Australia.

Data is entered into Pole Foundations computer software to account for the design parameters encountered on site. Using the "Assessed % RSV" calculated earlier in the process a revised strength value is derived for the wood pole. Once this value is known, a true factor of safety is calculated relative to the customers design requirements.

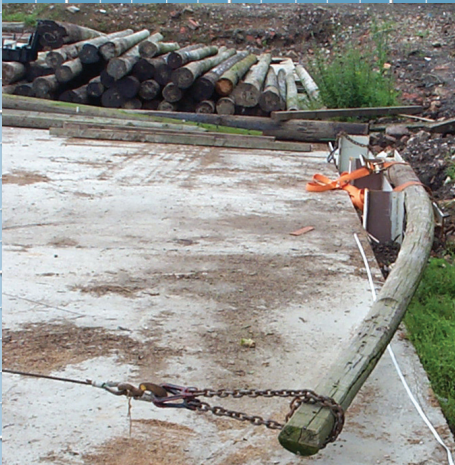
Testing & Research

Seventy wood poles were tested at an outdoor site using the non-destructive Pole Analysis and Structural Security 'PASS' process followed by destructive tests. The purpose of these tests were to consider the (PASS) protocol and compare the results of the Residual Strength Values (RSV) theoretically produced and resultant strength capability of the wood pole, to the actual strength of the wood pole following destructive testing. It was also the intention of these tests to consider the mechanisms of wood pole failure and improve still further the PASS process as a greater understanding of wood pole failure is acquired.
